S-E-C-R-E-T 25X1 COUNTRY Bulgaria REPORT 25X1 SUBJECT Bridge-like Construction on 12 September 1955 DATE DISTR. the Sofia-Vidin Line NO. OF PAGES 2 DATE OF INFO. REQUIREMENT NO. PLACE ACQUIRED REFERENCES 25X1 DATE ACQUIRED This is UNEVALUATED Information SOURCE EVALUATIONS ARE DEFINITIVE "APPRAISAL OF CONTENT IS TENTATIVE 25X1

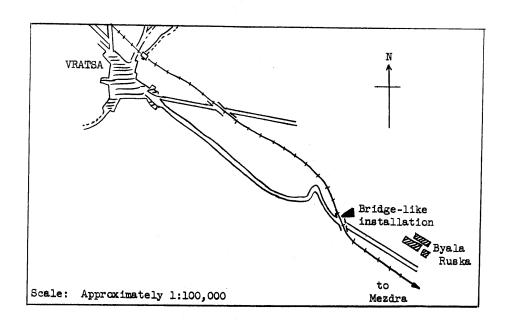
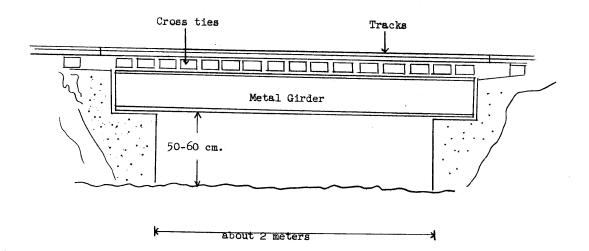
- In the vicinity of the village of Byala Ruska (N 43-10, E 23-29), Vratsa Okoliya, immediately north of the grade crossing on the Vratsa - Mezdra road, there is a bridge-like installation which very probably is for use in case the Sofia-Vidin railroad line should be damaged. The installation consists of a ditch approximately two meters long, 50 to 60 centimeters deep and as wide as the single-track line. It includes two concrete abutments arranged in steps, on which rest two very strong double-T metal girders, which are more than two meters long and approximately 25 centimeters high. A series of wooden cross-ties, laid next to one another, are perpendicular to the two metal girders. Railroad tracks rest on the crossties. Furthermore, there are four switches used to join the two sections of track with the rest of the line, from both sides of the bridge in question.

- In case of necessity, the above device could be rapidly put into operation by disconnecting one set of tracks and connecting the other.
- The sketches on page 2 show the location and layout of the bridge-like construction.
